<b>Subject:</b> <b>ENGINE WILL NOT START IN P-RANGE INTERMITTENTLY</b>	<b>Bulletin No:</b> 05-012/08
	<b>Last Issued:</b> 11/13/2008

2004-2008 Mazda3 vehicles with VINs lower than JM1BK\*\*\*\* \*\* 848579 (produced before November 1, 2007)

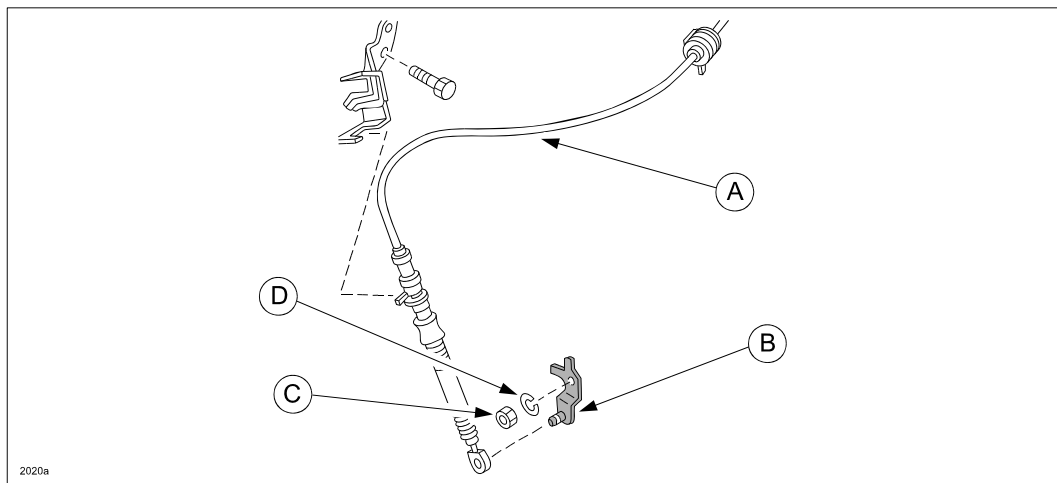
On some vehicles, the shift position lamp in the instrument cluster does not come on in the “P” position, and the engine does not start. However, the engine can be started in the “N” position. This is due to rust on the connecting point of the shift cable and lock cable lever causing the select lever not to move to the location where it is recognized as “P” range. There is no issue about the transmission reaching Park. This is only an issue about the confirming “P” indicator in the instrument cluster. A slit on the mud guard has been removed to prevent salt water from getting to the location where rust would occur.

1. Verify customer concern.
2. First verify that rust appears on the connecting point of the shift cable (A) and lock cable lever (B), then replace the lock cable lever with modified one by removing the nut (C) and washer (D). Also, replace the nut and washer.
