Subject: STARTER MOTOR WILL NOT CRANK AND ENGINE DOES NOT START (INTERMITTENTLY)	Bulletin No: 01-037/08
	Last Issued: 07/17/2008

2004 - 2008 Mazda3 vehicles (NOT including Mazdaspeed3)

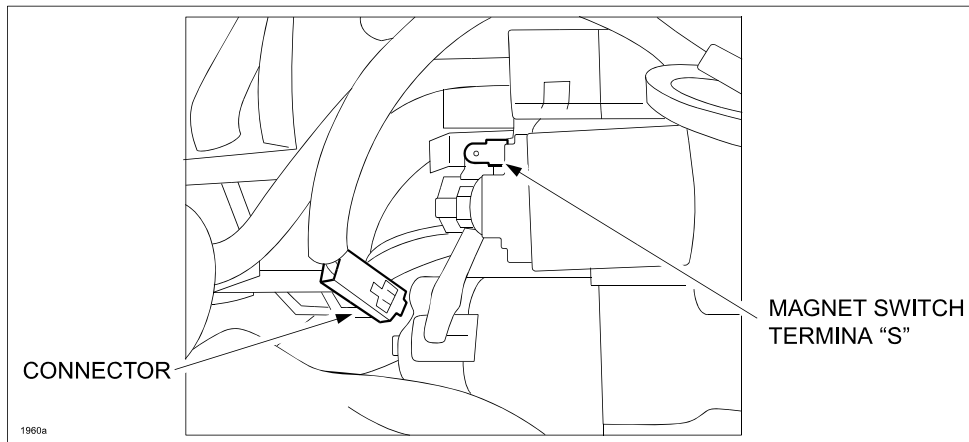
On some vehicles, the starter motor will not crank and the engine does not start. The problem is intermittent. This is caused by poor contact of the connector for the magnet switch terminal "S" in the starter motor.
