PRODEMAND

MULTIPLE ELECTRICAL MALFUNCTIONS AFTER BODY REPAIR

TECHNICAL SERVICE BULLETIN

Reference Number(s): 09-010/19, Date of Issue: August 07, 2019

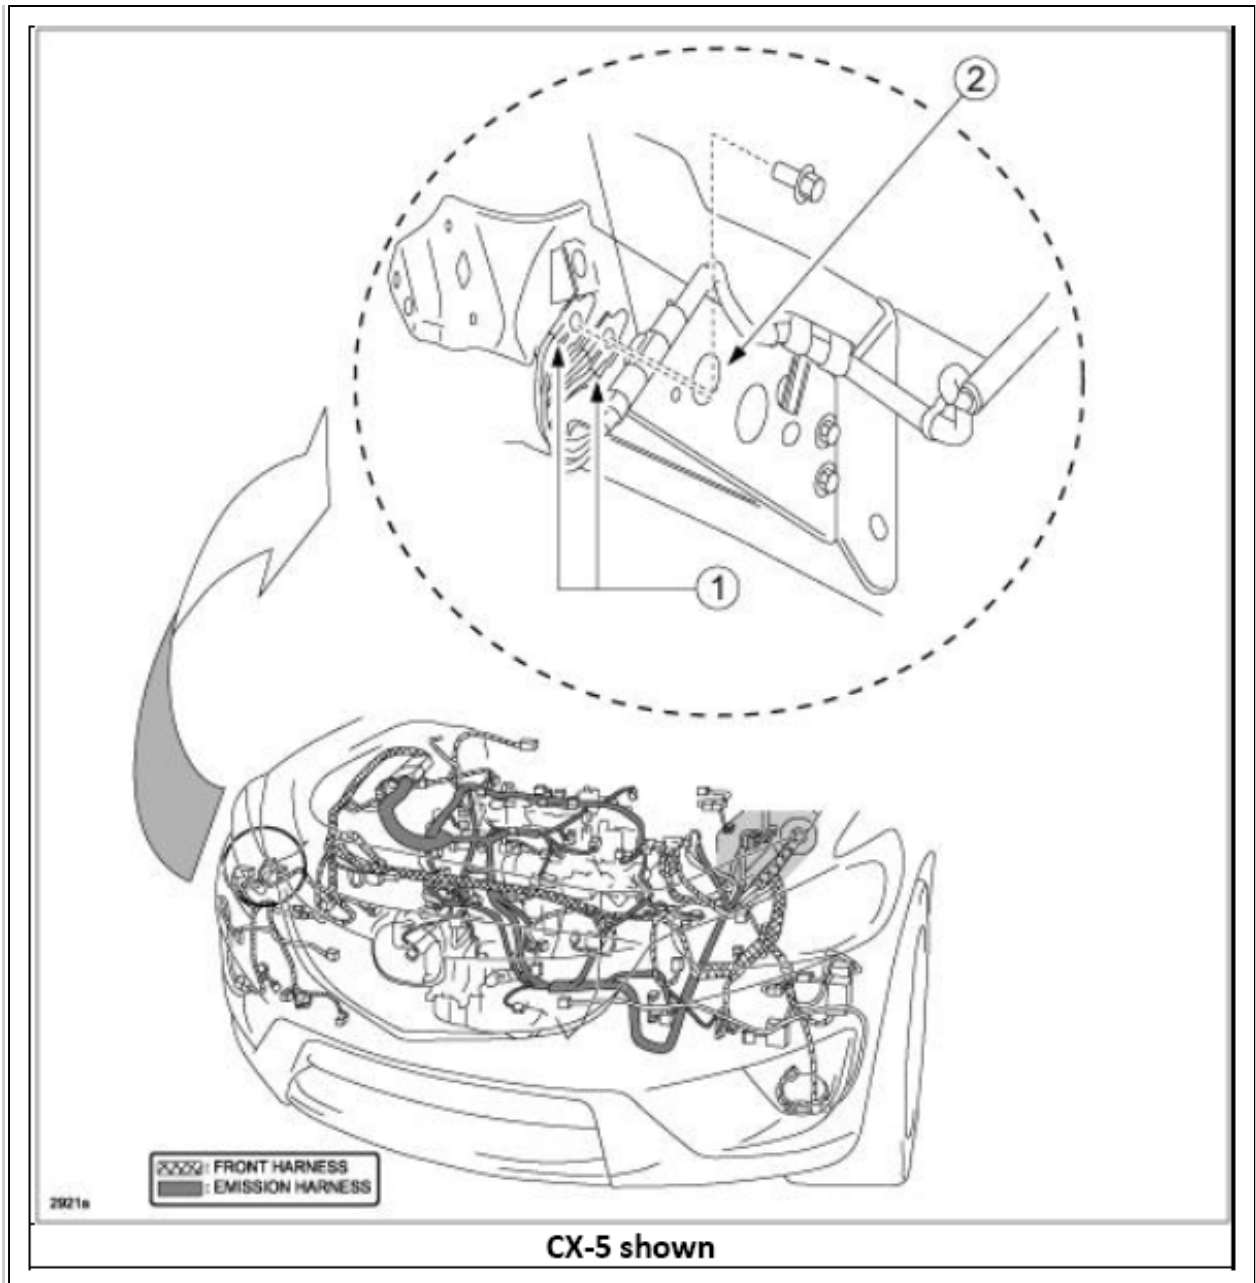
Some customers may experience one or more electrical malfunctions after a vehicle body repair. The newly painted fender stay (2) may be causing a poor front harness (1) ground connection.

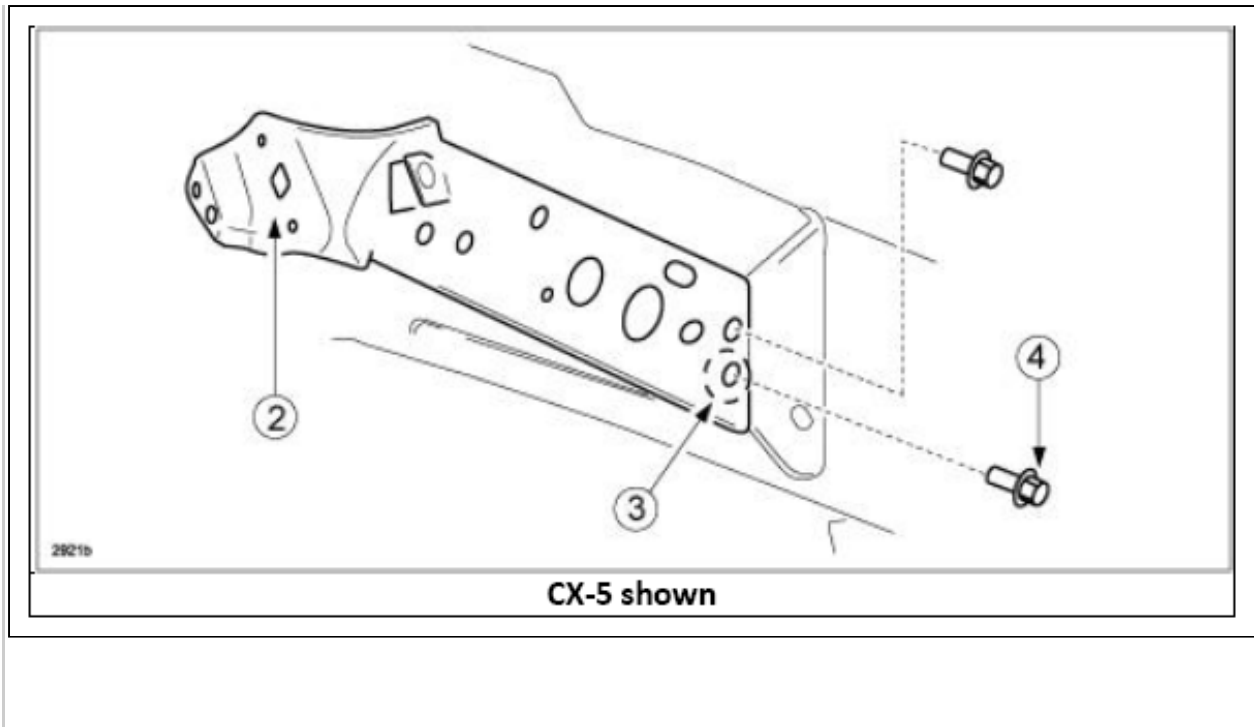
The front fender stay (2) newly painted surface at ground point (3), where attachment bolt (4) is seated, may create a poor front harness ground connection.

NOTE: Do not paint ground point (3) where attachment bolt (4) is seated.

Customer concern can be resolved by sanding off paint at ground point (3) where attachment bolt (4) is seated. After installing the bolt (4), apply touch-up paint to the exposed base material area of the front fender stay.

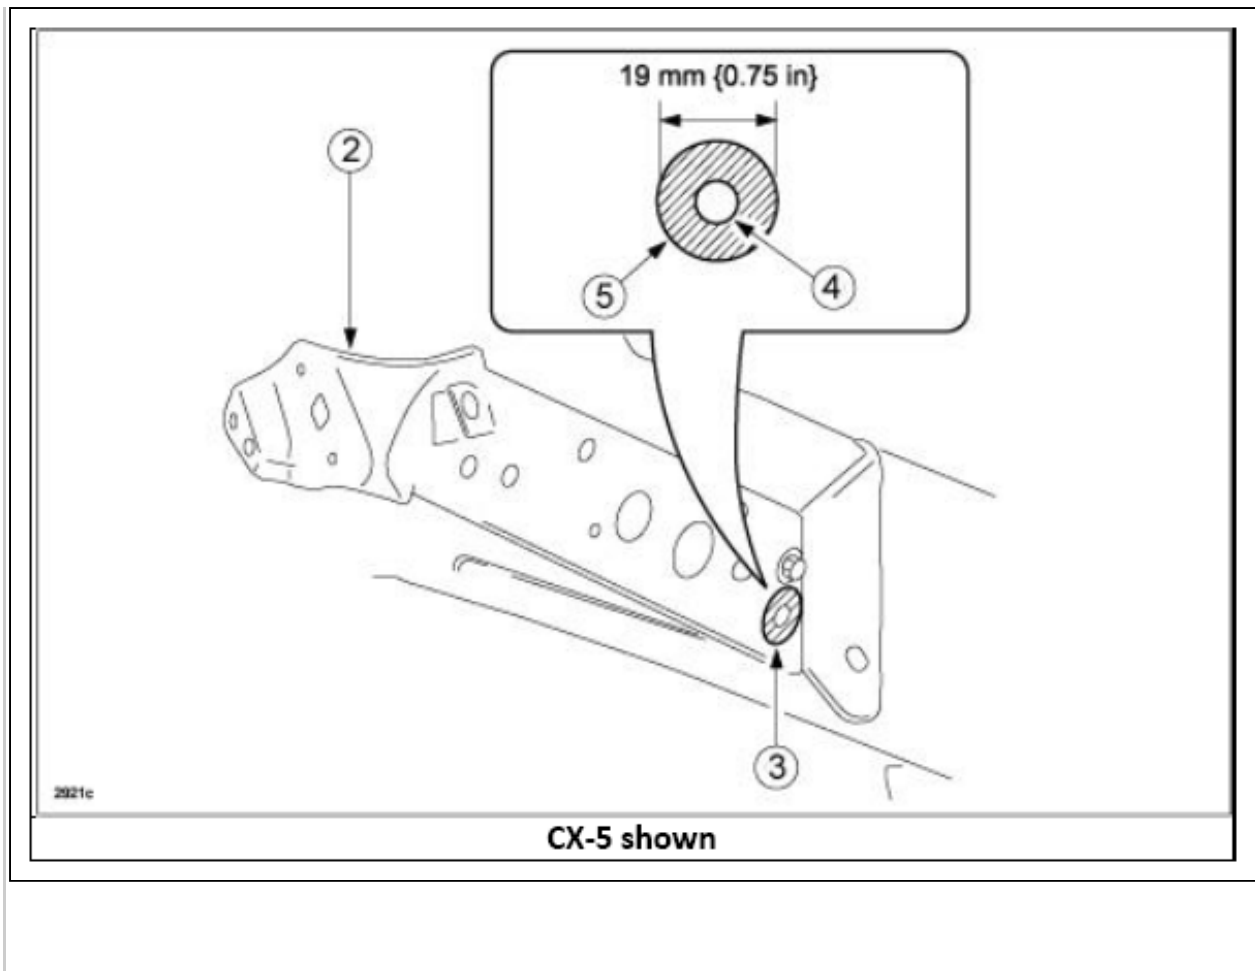
CAUTION: If the bolt (4) contact area (3) is painted when the front fender stay (2) is newly replaced, it could cause a malfunction in the PCM. Before painting a newly replaced part, protect the bolt (4) contact area (3) with masking tape (5) as shown in the figure.

NOTE: After installing the bolt (4), apply touch-up paint to the exposed base material area of the front fender stay.
